Field Report for Airborne Data Collected In Support of US EPA Region 6 Intercontinental Terminals Company LLC Fire 27 March 2019

Data Results Flight 14, 27 March 2019

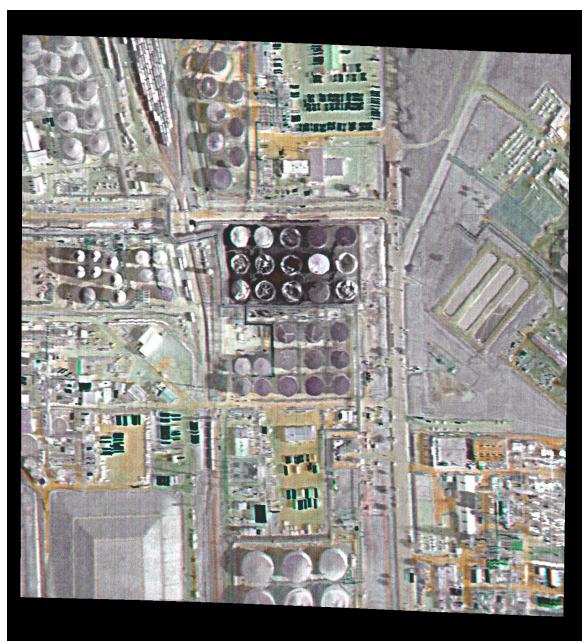
Figure 3: IR image of ITC data for 27 March 2019, Flight 14 Run 2

A total of 1 test and 7 data passes were made in the proximity of the impacted tank farm and also in extended areas surrounding the site and infrared line scanner images were generated for each pass. Figure 3 shows a typical 3-band infrared image obtained from data collected for Run 2. IR imagery is now showing fine detail on the tank surfaces and there is effectively no detector saturation. Figure 4 is a thermal image and which confirms the finding of the line scanner and shows tank surface features of tanks at ambient temperature (some solar heating is occurring). As with other thermal images, note that the bottom right in the image is the NW due to the image being inverted.

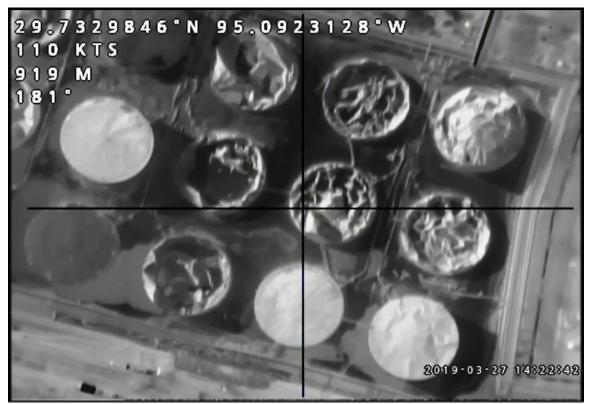
Figure 4: IR Thermal Analysis 27 March 2019, Flight 14, Run 8

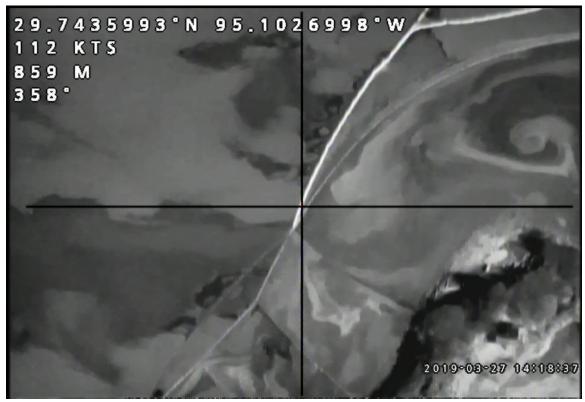
continues to trap material with leakage can be seen across the channel mouth and also upstream within the drainage channel. Sheen leakage can be seen in the southwest edge of the boom (Figure 5). Figure 6 is a thermal image of the boom area and clearly shows the some boom leakage.

Figure 6: IR Image of Contained Oil 27 March 2019, Fight 14, Run 7

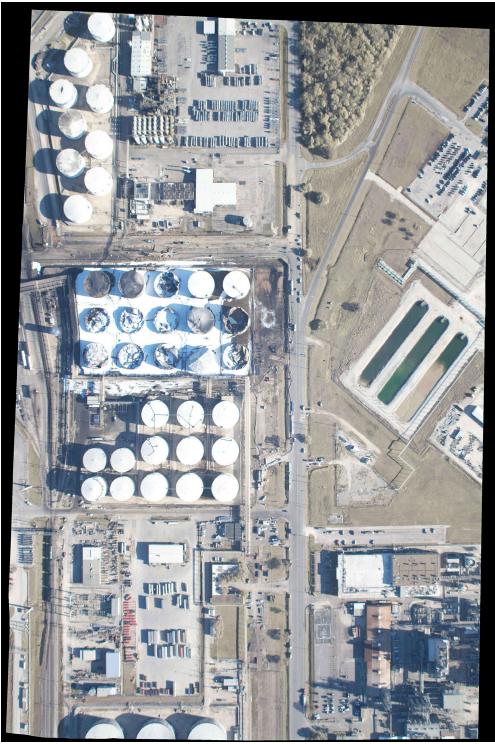
A full set of high resolution aerial digital photography was collected as part of the flight. Figure 7 shows a representative overhead image collected as part of each pass over the tank farm. There is effectively little new information that can be extracted for the tank farm. Figure 8 provides an overhead view of the confluence area. The amount of trapped product appears to be less than on prior missions. The image does not show boom leakage. The same area as viewed using the oblique camera downs more detail of the trapped product and does show some leakage from one boom layer to the next. Little leakage is evident from the main booms

Figure 6: Aerial Image of the Tank Farm, 27 March 2019, Flight 14

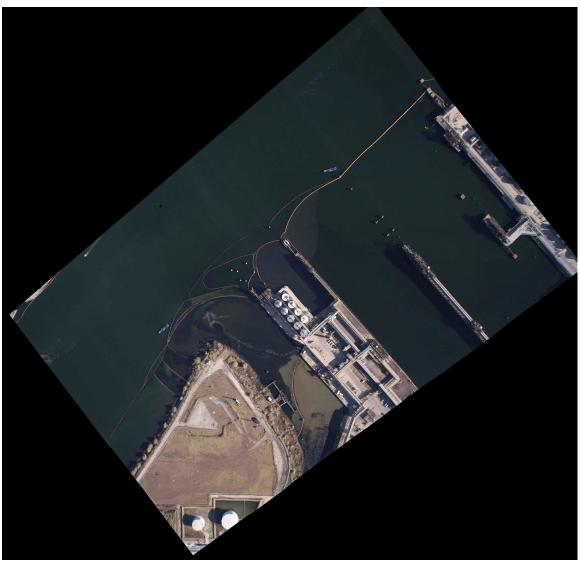
Figure 7: Aerial Image of the Ship Channel Boom Area, 27 March 2019, Flight 14
